Fretting Fatigue behaviour of Press-Fit Joints of AM Parts by Digital Image Correlation and micro-Computed Tomography

S. Horn, I. Bacaicoa, A. Brückner-Foit

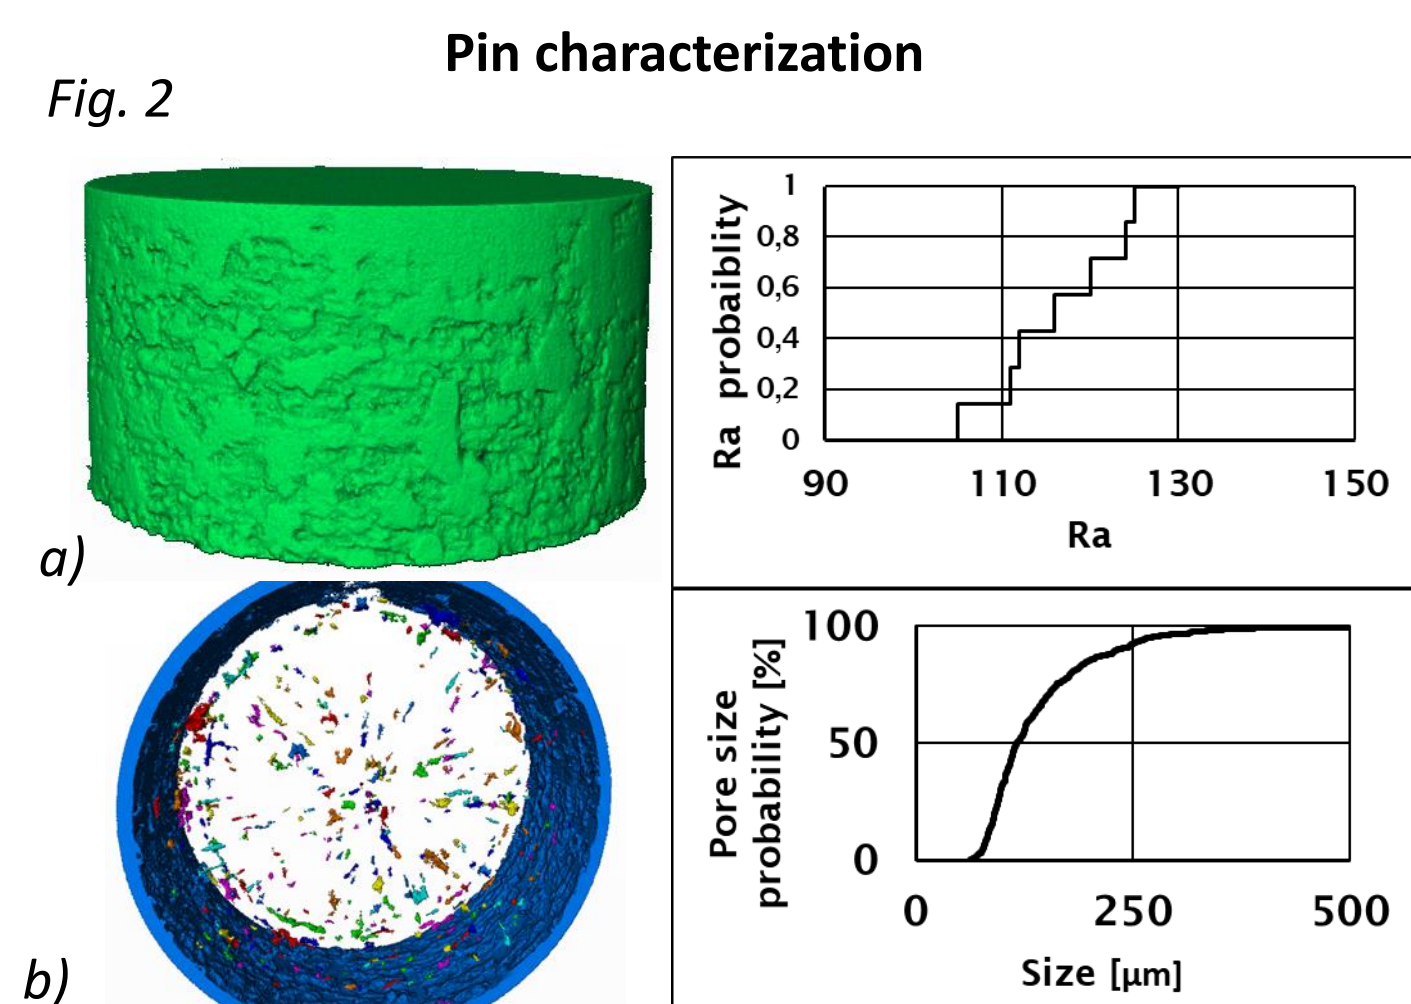
The 3D pin geometry, alongside internal pores, was acquired via μ -CT (Fig. 2) and imported into FE-software to simulate the stress distribution (Fig 4). Simulations were then compared it with idealized geometries (Fig 5).

CT-scans of the pin geometry revealed a considerable plastic deformation. Therefore simulation of the pressing process and comparative μ -CT scans will be considered in further research. Simulation with an idealized pin (Fig. 4a and 5.b) underlined the suitability of the sample geometry to induce strain onto the pin surface. For not perfectly aligned pins, a certain eccentricity is observed leading to four stress peaks, which coincided with crack initiation spots in SEM micrographs (Fig. 6). Therein, shear induced crack initiation can be identified, which is typical for fretting fatigue. Digital Image Correlation during cyclic loading displays high strain concentrations on the sample surface (Fig 3.), that can be correlated with the roughness tips of the pin.
